INSPECTION CONDITIONS

FILE #: 000123.
DATE OF INSPECTION: August 8, 2006.
TIME OF INSPECTION: 09:00 AM.
INSPECTOR Lou Schneider.
CLIENT NAME: Mr. Taylor Brown.
MAILING ADDRESS: 123 Main Street.
CLIENT CITY/STATE/ZIP: Ocean City, MD 21842.
INSPECTION SITE: 123 Fifth Avenue.
**INSPECTION SITE CITY/
STATE/ZIP:** Ocean City, MD 21842.

Sample Report

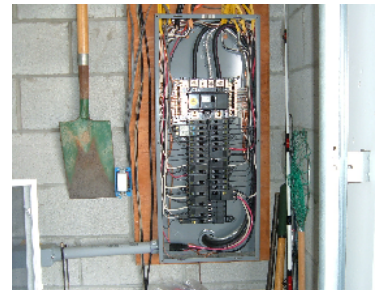
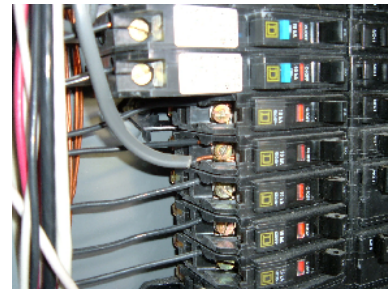
Inspector Notes: Multiple wires are connected to a single lug on a circuit breaker where only one wire should be connected.

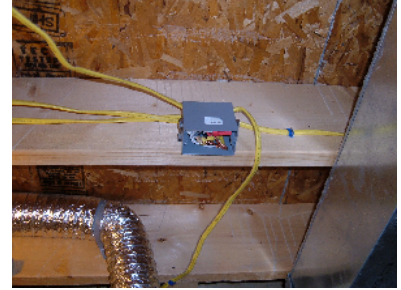
Missing or damaged cover plates viewed. There are a couple of lights in the utility area that do not have a junction box.

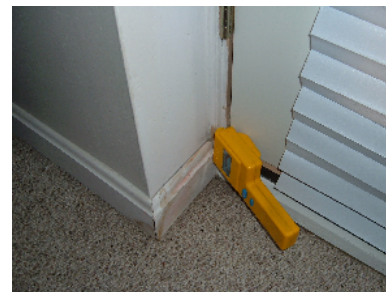
The lower doors at the rear deck have active moisture at the bottom trim.
