INSPECTION CONDITIONS

FILE #: 000123.
DATE OF INSPECTION: August 8, 2006.
TIME OF INSPECTION: 09:00 AM.
INSPECTOR Lou Schneider.
CLIENT NAME: Mr. Taylor Brown.
MAILING ADDRESS: 123 Main Street.
CLIENT CITY/STATE/ZIP: Ocean City, MD 21842.
INSPECTION SITE: 123 Fifth Avenue.
**INSPECTION SITE CITY/
STATE/ZIP:** Ocean City, MD 21842.

Sample Report

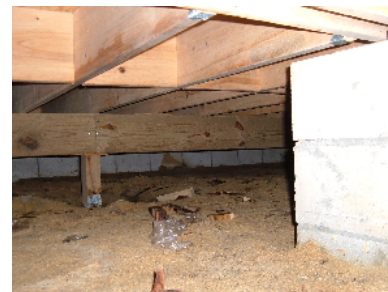
BEAM - MATERIAL & CONDITION:

Laminated Wood, Inspected- No major defects were found.

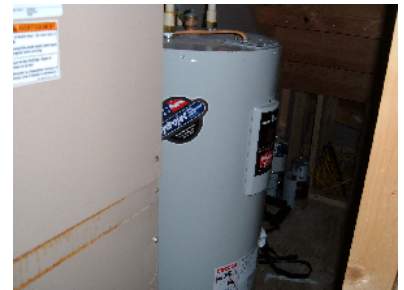
WATER HEATER:

TYPE: Electric.
MANUFACTURER: Bradford - White.

SIZE: 50 Gallons.
LOCATION: Utility room.
MODEL: MI50S6DS13.
SERIAL NUMBER: ZB2747180.
CONDITION: Inspected- No major defects were found.
